CASE STUDY

Maintaining a safe connection – Nordland project drives progress in structural assessment

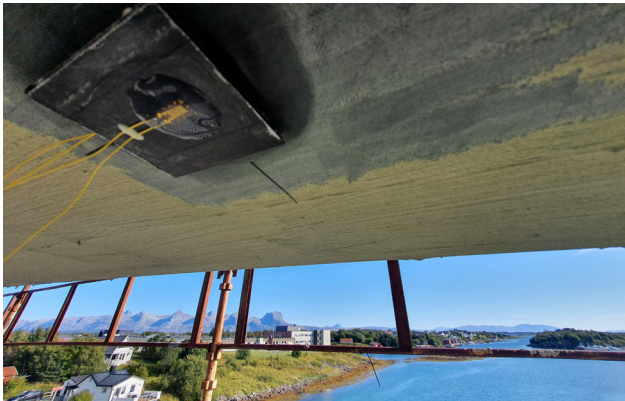
Strain gauge with temperature compensation (the Seven Sisters mountain range can be seen in the background)

With the system chosen, the project team embarked on their work. To enhance the structural integrity of the bridge, sheets of carbon fiber were securely adhered beneath it. Along the main span of the bridge, thirteen HBK strain gauges and a PT100 temperature measurement sensor were installed. In addition to the strain gauges and temperature sensor, two custom-designed Ohm-shaped 'Omega' sensors were also installed. Manufactured by HBK in France and calibrated at its facility in Paris, these

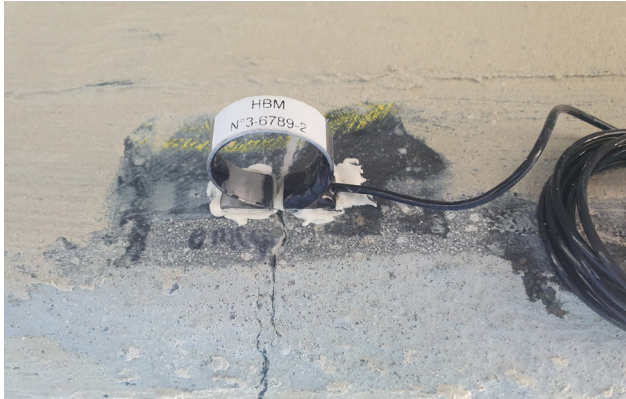
Custom-designed 'Omega' sensor

sensors were specifically designed to monitor changes in crack width, a crucial parameter for assessing structural health. To facilitate data acquisition and storage, a custom-made cabinet was positioned at the base of the bridge, housing a QuantumX amplifier, an industrial PC, catman software, and other measurement equipment. This setup ensured accurate measurement and reliable storage of the collected data.
